18. METEOROID-DETECTOR DEPLOYMENT AND PRESSURIZATION SYSTEMS

By H. C. Halliday
NASA Langley Research Center

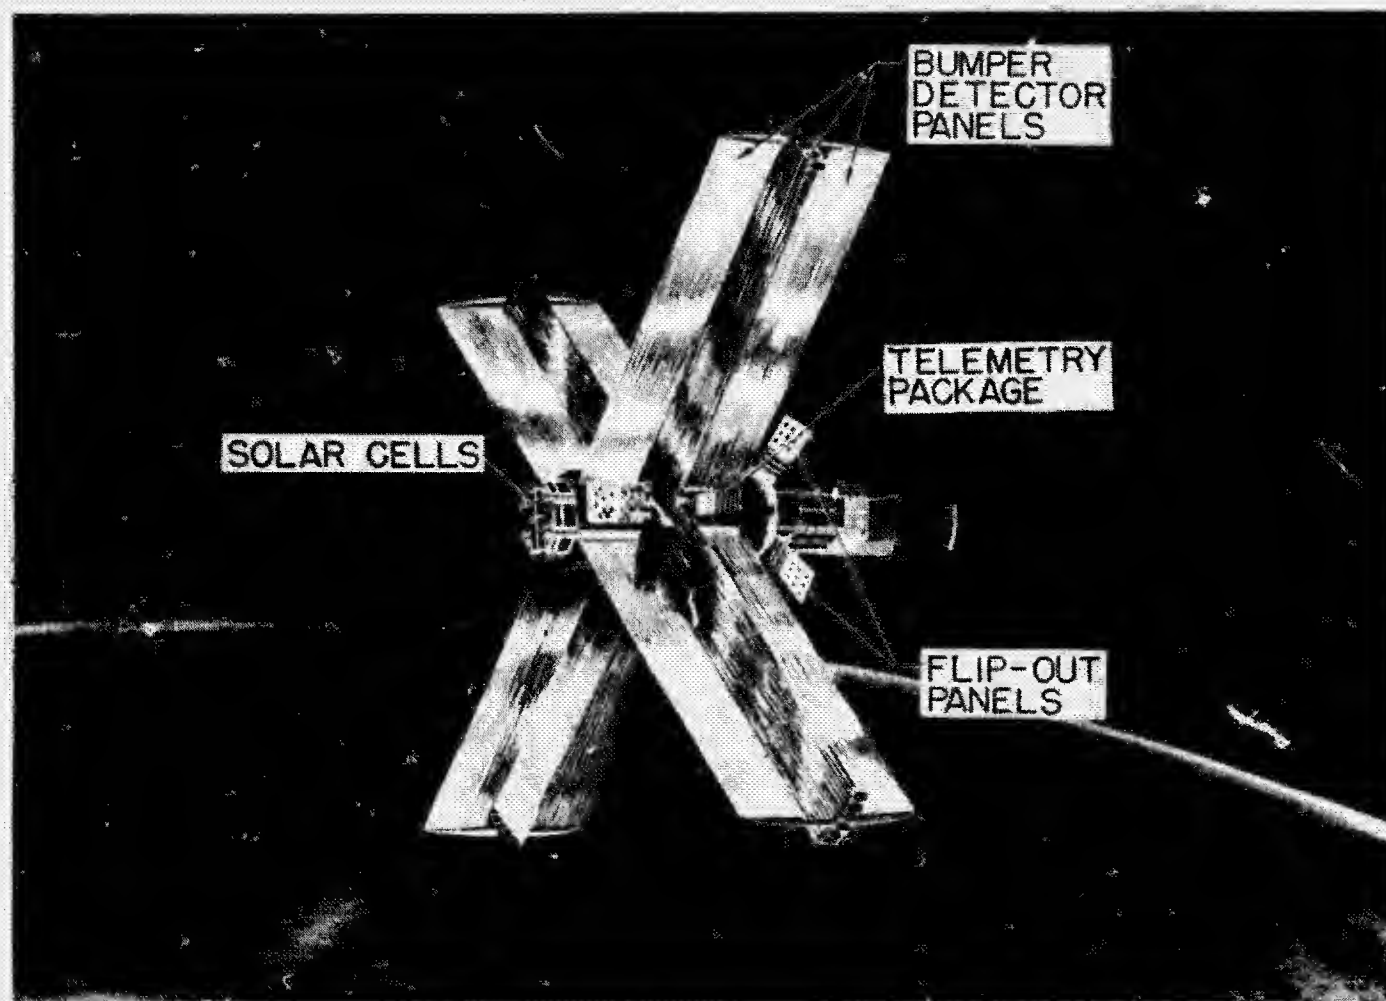
Figure 1.- Meteoroid Technology Satellite (MTS). Explorer 46.

The Explorer 46 Meteoroid Technology Satellite (MTS, fig. 1) was designed to collect data on the near-earth environment and its effect on spacecraft structures. The data will be utilized to evaluate the meteoroid protection provided by a typical bumper-protected multisheet spacecraft structure.
